Manhole Inspection Summary

Manhole # S15CC1003MH

Insp Date: **3/14/07 1:54 PM**

Location Address: **3801 COTTAGE AVE**

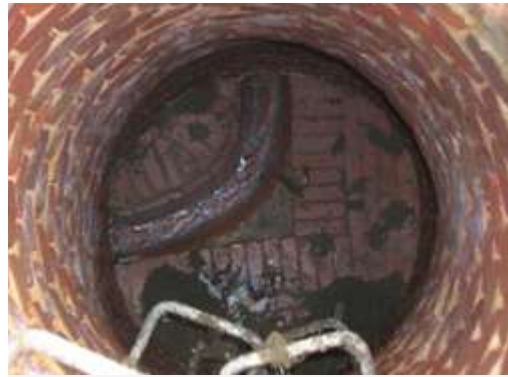
Top View

Evidence of surcharge - Bench debris.
Corroded steps.

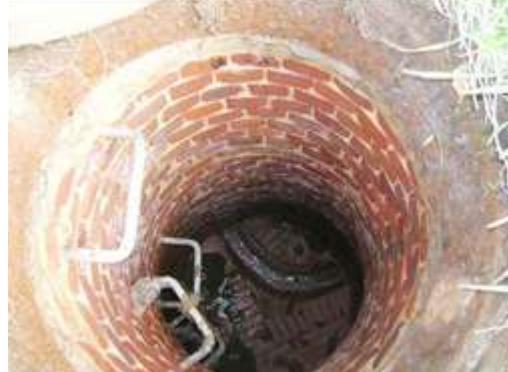
Defect

Frame leaks. Adjustment and Barrel
infiltration.

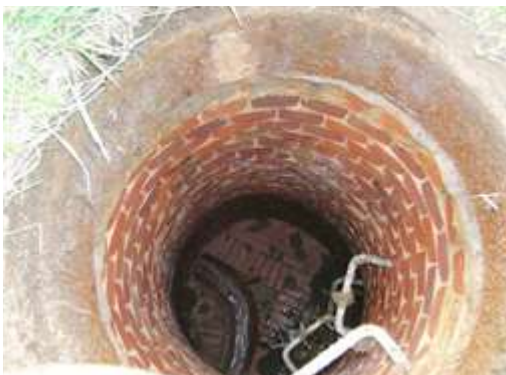
Defect

Frame leaks. Adjustment and Corbel
infiltration - other side.

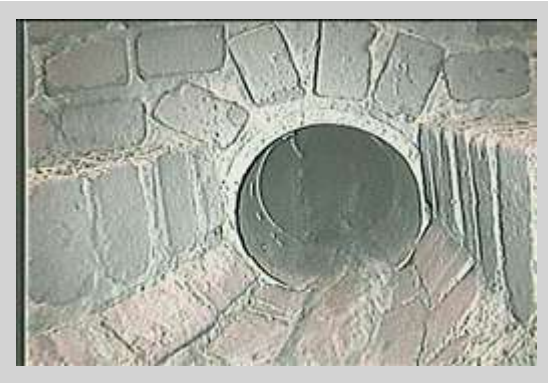
8 in. Circular Gravity Sewer Pipe Out @ 12 O'Clock

Channel deterioration.

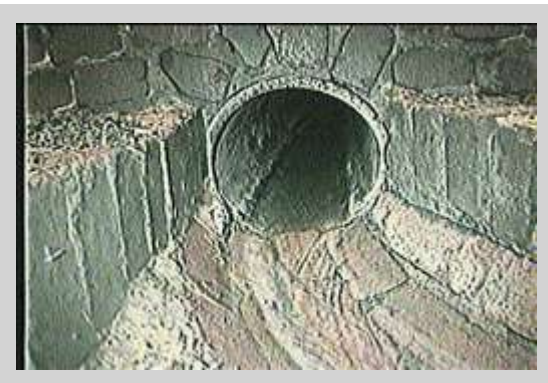
8 in. Circular Gravity Sewer Pipe In @ 9 O'Clock

Barrel deterioration and infiltration. Channel deterioration.

Infiltration: **Evidence** Pipe Seal Cond: **Unknown**
